# 1826 CHESTNUT ST.

march 30, 2023 | center city residents association

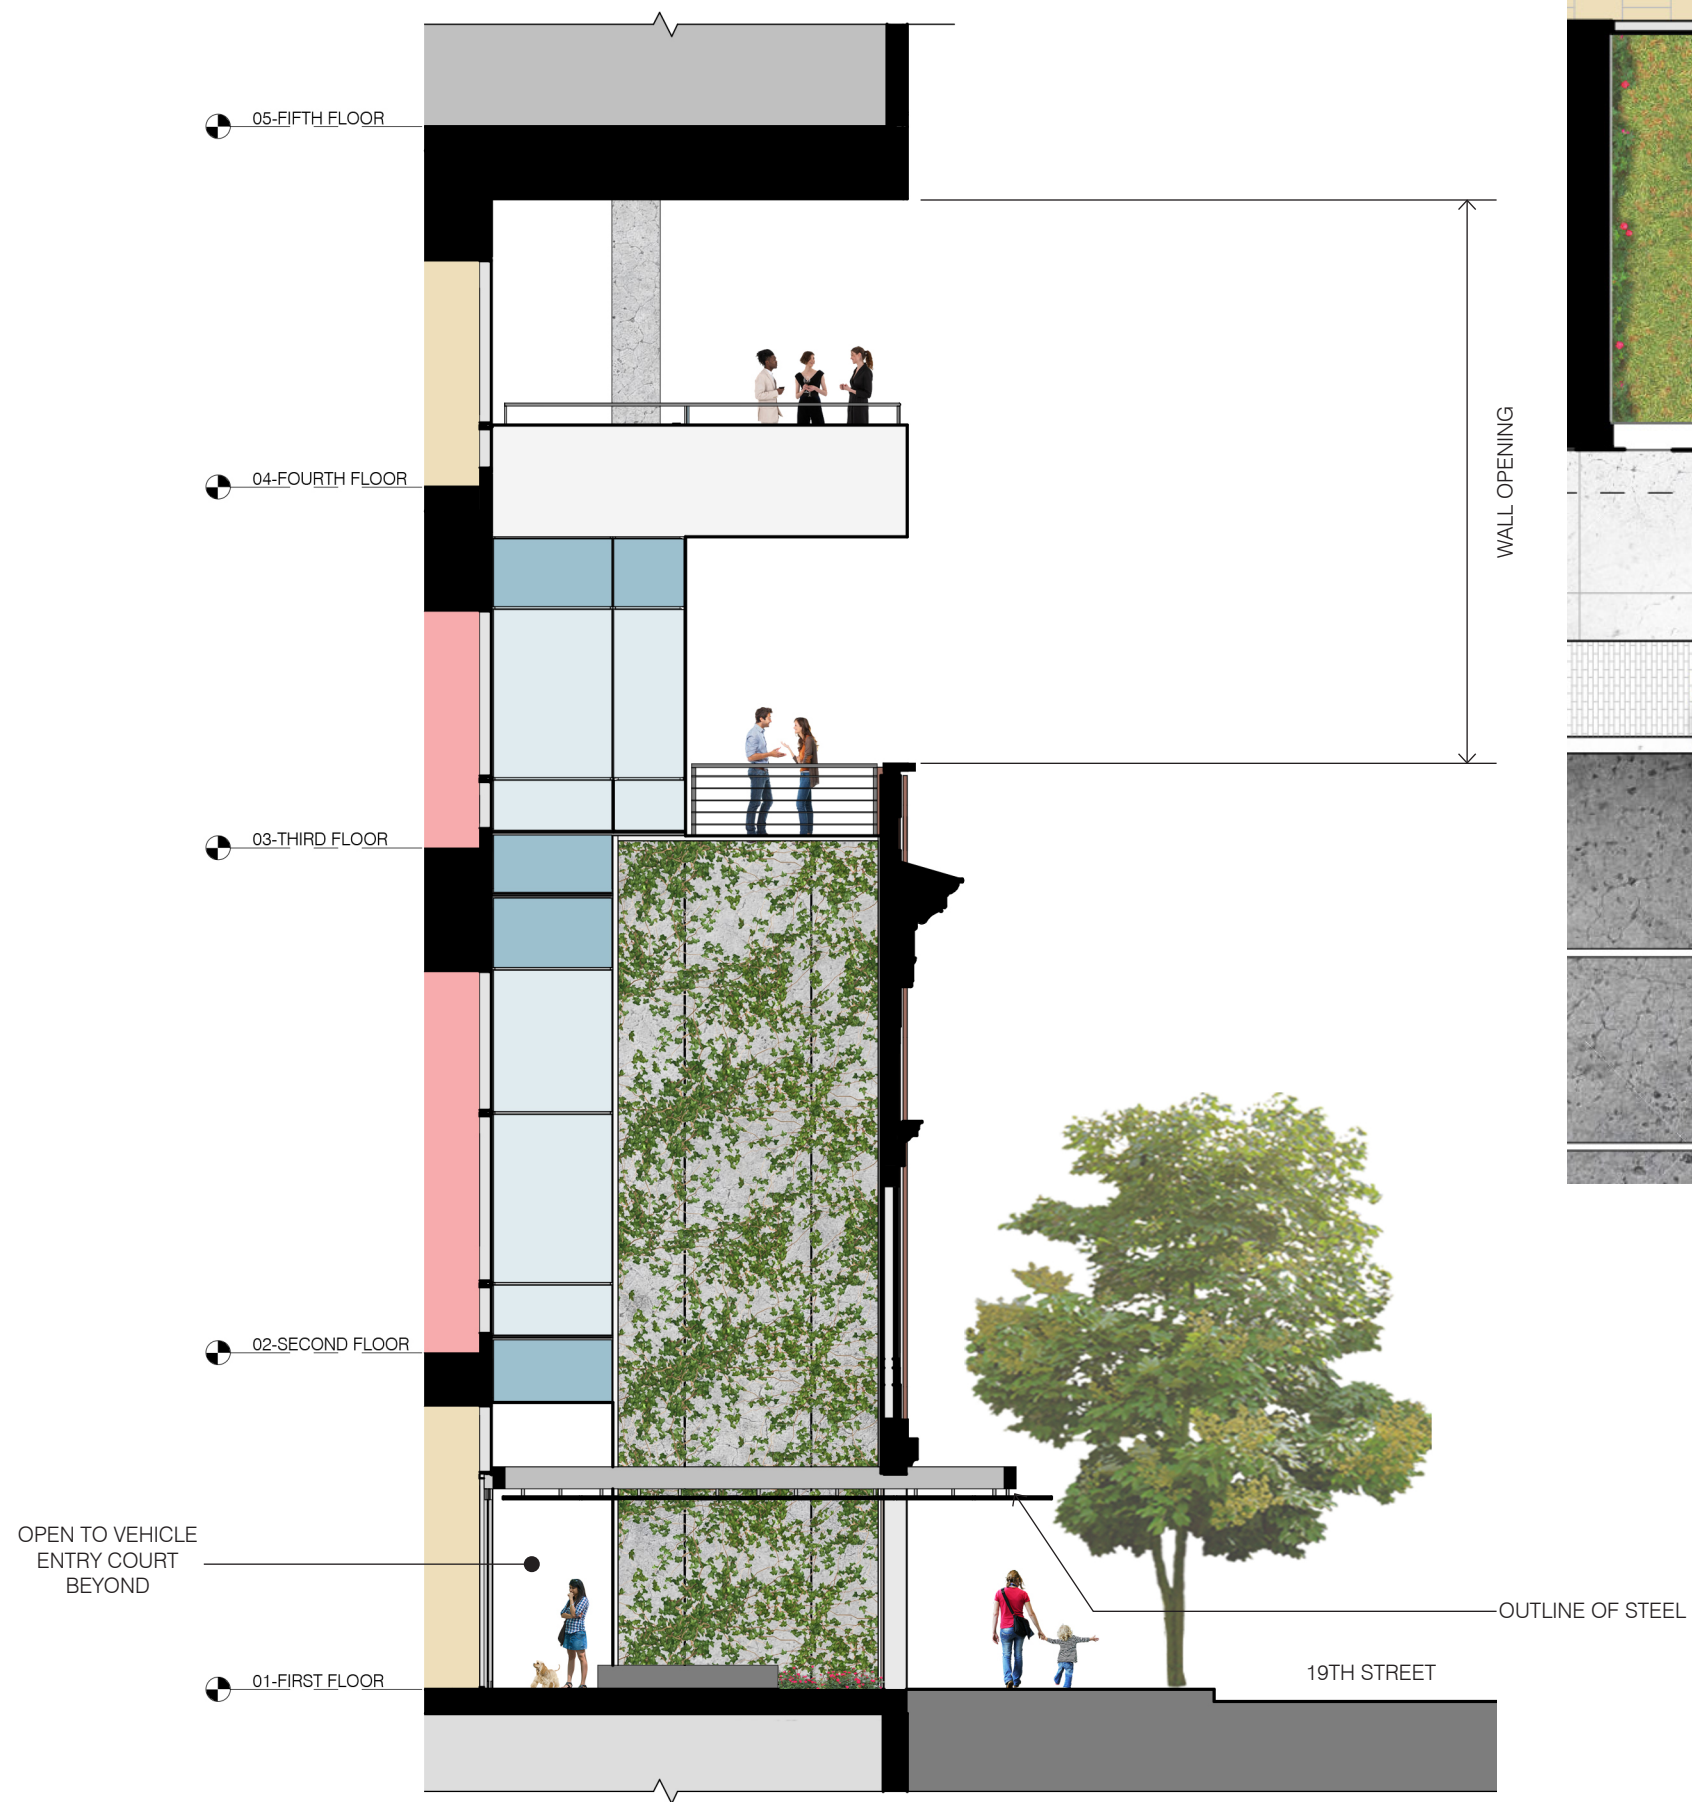
EAST-WEST SECTION

GROUND FLOOR CALLOUT
